## Asbestos Surveying Services

Refurbishment/Demolition Survey  
Of  
Bishop House  
110 Walm Lane  
Willesden Green  
London  
NW2

**Date:** 30<sup>th</sup> September 2015

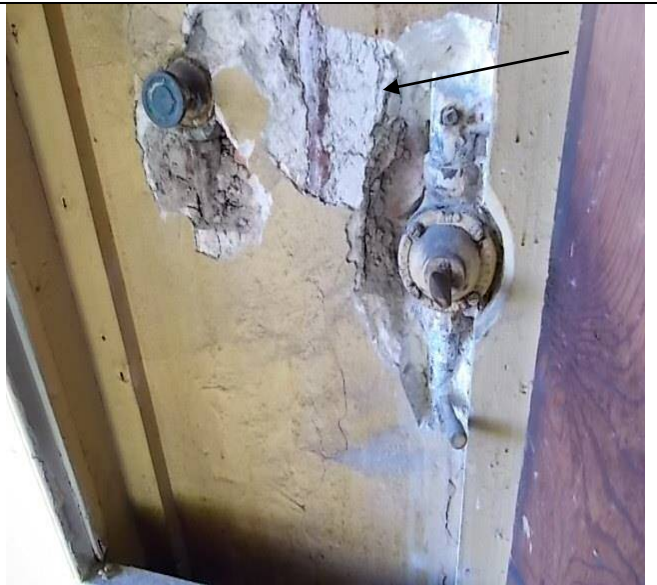
<b>Sample Reference:</b>	Inspection Point 01 Sample 1	<b>Asbestos Type:</b>	<b>No Asbestos Detected In Sample (NADIS)</b>
<b>Sample Location:</b>	Room 1 – Stage Area 2 <sup>nd</sup> Floor	<b>Product type:</b>	N/A
<b>Sample Description:</b>	Plaster to walls throughout property	<b>Accessibility</b>	N/A
		<b>Extent</b>	N/A
<b>Extent of Damage</b>	N/A	<b>Material Risk Assessment Total</b>	0
<b>Surface Treatment</b>	N/A	<b>Potential for Fibre Release</b>	N/A
<b>Recommended Action:</b>	<b>No asbestos was detected in sample. No further action required.</b>

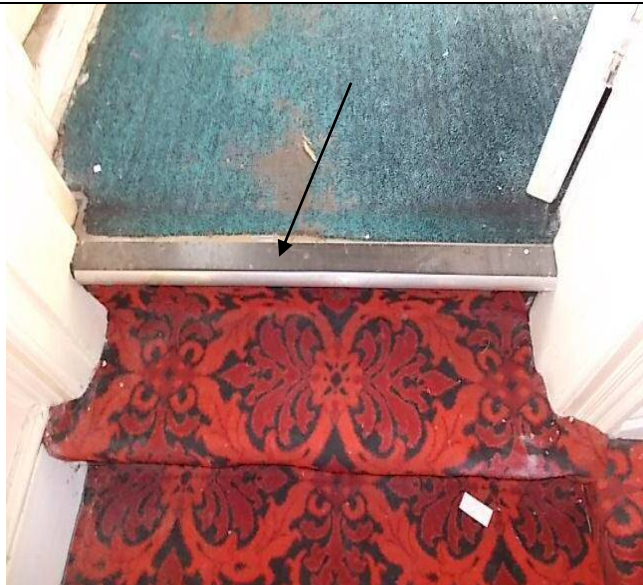
<b>Sample Reference:</b>	Inspection Point 06 Sample 6	<b>Asbestos Type:</b>	<b>No Asbestos Detected In Sample (NADIS)</b>
<b>Sample Location:</b>	Room 5 – Office 1st Floor	<b>Product type:</b>	N/A
<b>Sample Description:</b>	Bitumen stair nosing in entrance of room	<b>Accessibility</b>	N/A
		<b>Extent</b>	N/A
<b>Extent of Damage</b>	N/A	<b>Material Risk Assessment Total</b>	0
<b>Surface Treatment</b>	N/A	<b>Potential for Fibre Release</b>	N/A
<b>Recommended Action:</b>	<b>No asbestos was detected in sample. No further action required.</b>

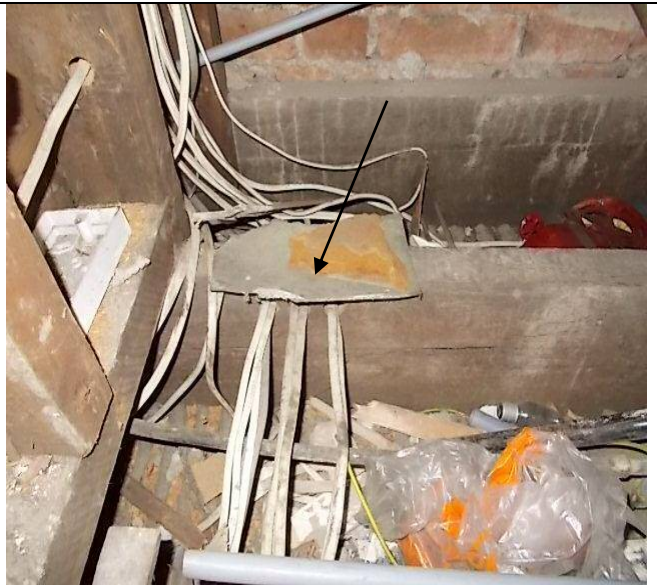
<b>Sample Reference:</b>	Inspection Point 08 Sample 7	<b>Asbestos Type:</b>	<b>No Asbestos Detected In Sample (NADIS)</b>
<b>Sample Location:</b>	Room 7 Cupboard under Stairs 1st Floor	<b>Product type:</b>	N/A
<b>Sample Description:</b>	Floortiles and bitumen adhesive to side of room	<b>Accessibility</b>	N/A
		<b>Extent</b>	N/A
<b>Extent of Damage</b>	N/A	<b>Material Risk Assessment Total</b>	0
<b>Surface Treatment</b>	N/A	<b>Potential for Fibre Release</b>	N/A
<b>Recommended Action:</b>	<p><b>No asbestos was detected in sample.</b> <b>No further action required.</b></p>

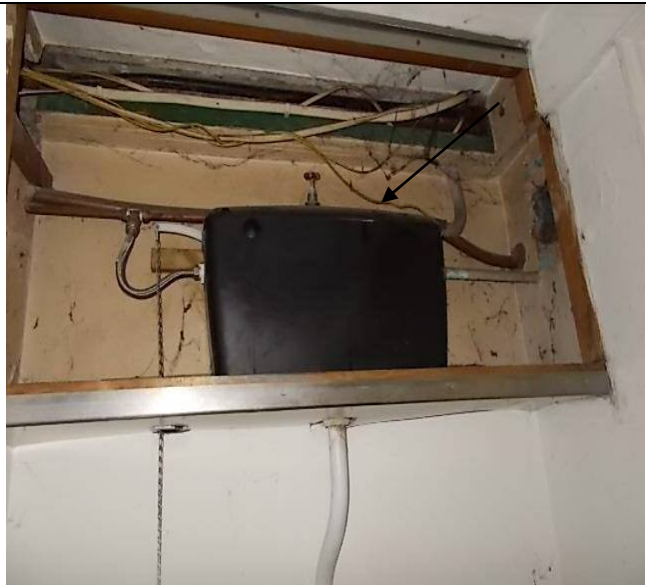
<b>Sample Reference:</b>	Inspection Point 12 Sample 11	<b>Asbestos Type:</b>	<b>No Asbestos Detected In Sample (NADIS)</b>
<b>Sample Location:</b>	Room 6 –W/C Cubicle Ground Floor	<b>Product type:</b>	N/A
<b>Sample Description:</b>	W/C Cistern	<b>Accessibility</b>	N/A
		<b>Extent</b>	N/A
<b>Extent of Damage</b>	N/A	<b>Material Risk Assessment Total</b>	0
<b>Surface Treatment</b>	N/A	<b>Potential for Fibre Release</b>	N/A
<b>Recommended Action:</b>	<b>No asbestos was detected in sample. No further action required.</b>

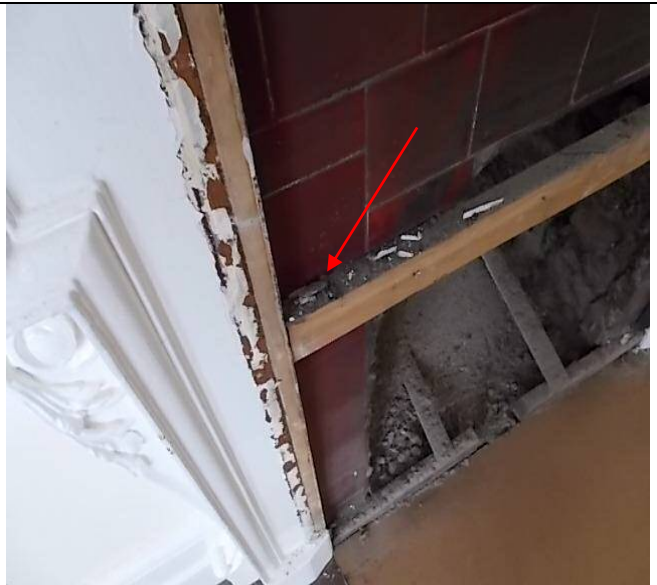
<b>Sample Reference:</b>	Inspection Point 16 Sample 14	<b>Asbestos Type:</b>	<b>Amosite/Chrysotile</b>
<b>Sample Location:</b>	Room 9 – Office Ground Floor	<b>Product type:</b>	Asbestos Insulating Board Debris
<b>Sample Description:</b>	Asbestos Insulating Board Debris on timber frame within fireplace	<b>Accessibility</b>	Easily Accessed
		<b>Extent</b>	< 1 m <sup>2</sup>
<b>Extent of Damage</b>	High Damage	<b>Material Risk Assessment Total</b>	9
<b>Surface Treatment</b>	Not Sealed	<b>Potential for Fibre Release</b>	Medium
<b>Recommended Action:</b>	<b>Remove and environmentally clean area using a licensed contractor in accordance with the Control of Asbestos Regulations 2012.</b>

- 5) Inspection Points 11 and 14 were identified as containing Amosite. We recommend these incidences be labelled and managed or removed using a Competent Contractor under controlled conditions in accordance with the Control of Asbestos Regulations 2012.

We recommend IP/16 be removed and the area environmentally cleaned by a Licensed contractor in accordance with the Control of Asbestos Regulations 2012.

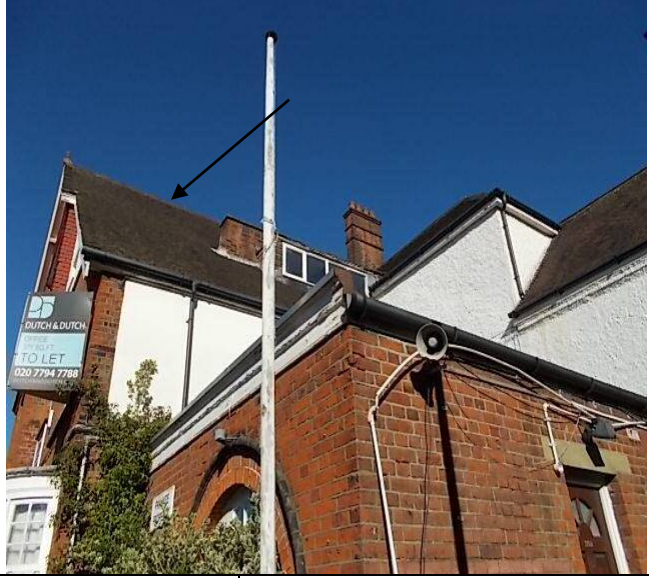
<b>Sample Reference:</b>	Inspection Point 18 Sample 16	<b>Asbestos Type:</b>	<b>No Asbestos Detected In Sample (NADIS)</b>
<b>Sample Location:</b>	External	<b>Product type:</b>	N/A
<b>Sample Description:</b>	Bitumen felt to roof of 2 <sup>nd</sup> floor	<b>Accessibility</b>	N/A
		<b>Extent</b>	N/A
<b>Extent of Damage</b>	N/A	<b>Material Risk Assessment Total</b>	0
<b>Surface Treatment</b>	N/A	<b>Potential for Fibre Release</b>	N/A
<b>Recommended Action:</b>	<b>No asbestos was detected in sample. No further action required.</b>

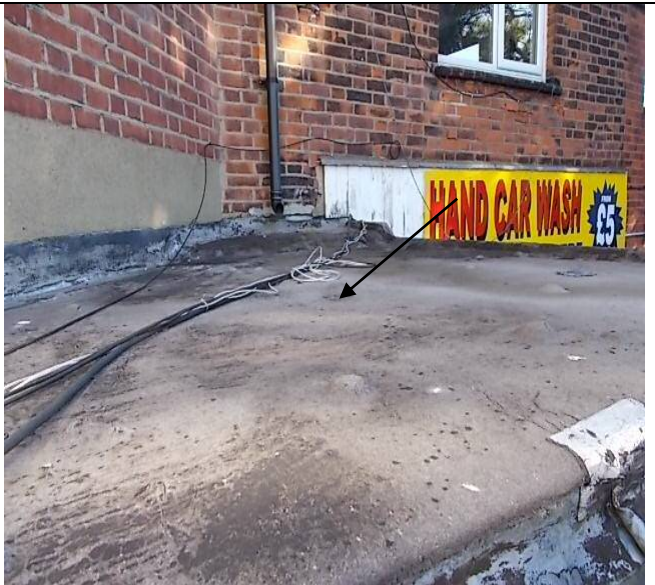
<b>Sample Reference:</b>	Inspection Point 20 Sample 18	<b>Asbestos Type:</b>	<b>No Asbestos Detected In Sample (NADIS)</b>
<b>Sample Location:</b>	External Ground Floor	<b>Product type:</b>	N/A
<b>Sample Description:</b>	Bitumen Felt to flat roof at the side of the property	<b>Accessibility</b>	N/A
		<b>Extent</b>	N/A
<b>Extent of Damage</b>	N/A	<b>Material Risk Assessment Total</b>	0
<b>Surface Treatment</b>	N/A	<b>Potential for Fibre Release</b>	N/A
<b>Recommended Action:</b>	<b>No asbestos was detected in sample. No further action required.</b>

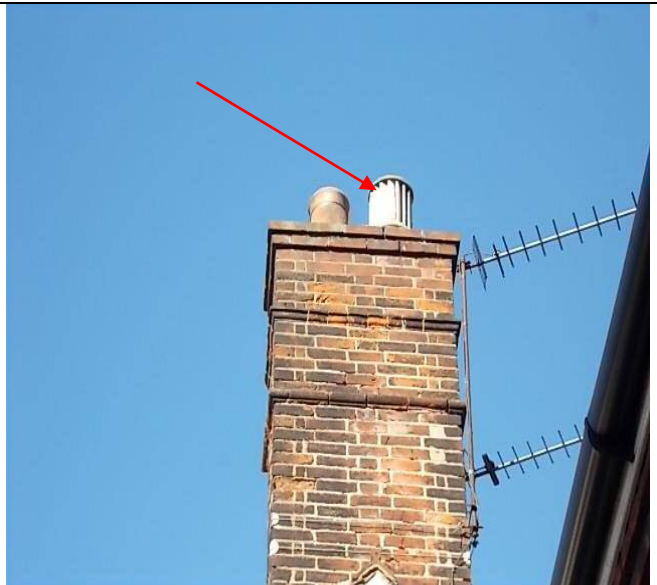
<b>Sample Reference:</b>	Inspection Point 21 Strongly Presumed	<b>Asbestos Type:</b>	<b>Chrysotile</b>
<b>Sample Location:</b>	External	<b>Product type:</b>	Asbestos Cement
<b>Sample Description:</b>	Strongly Presumed cement cowling to top of chimney	<b>Accessibility</b>	Easily Accessed
		<b>Extent</b>	< 1 m <sup>2</sup>
<b>Extent of Damage</b>	Good Condition	<b>Material Risk Assessment Total</b>	3
<b>Surface Treatment</b>	Not Sealed	<b>Potential for Fibre Release</b>	Very Low
<b>Recommended Action:</b>	<b>Label and manage or remove using a competent contractor in accordance with the Control of Asbestos Regulations 2012.</b>

Inspection No.	Description	Location	Asbestos Type	Quantity	Recommended Action
Inspection Point 21 Strongly Presumed	Strongly Presumed cement cowl to top of chimney	External	Chrysotile	< 1 m <sup>2</sup>	<b>Label and manage or remove using a competent contractor in accordance with the Control of Asbestos Regulations 2012.</b>
Inspection Point 22 Sample 19	Bitumen flashing to top of sign above entrance of garage	External	Chrysotile	4 Lm x 100 mm	<b>Label and manage or remove using a competent contractor in accordance with the Control of Asbestos Regulations 2012.</b>
Inspection Point 24 Sample 21	Rope beading to glass sky-light	External Flat Roof 1	Chrysotile	14 Lm	<b>Label and manage or remove using a competent contractor in accordance with the Control of Asbestos Regulations 2012.</b>
No Access	No access was gained to Room 3 on the second floor	Room 3 – 2 <sup>nd</sup> Floor	N/A	N/A	<b>Further investigation would be required to confirm or refute the presence of asbestos in this area.</b>

- 3) Inspection Points 09 and 21 were identified as containing Chrysotile.  
We recommend IP/09 be removed by a competent Contractor in accordance with the Control of Asbestos Regulations 2012.  
We recommend IP/21 be labelled and managed or removed by a Competent contractor in accordance with the Control of Asbestos Regulations 2012.

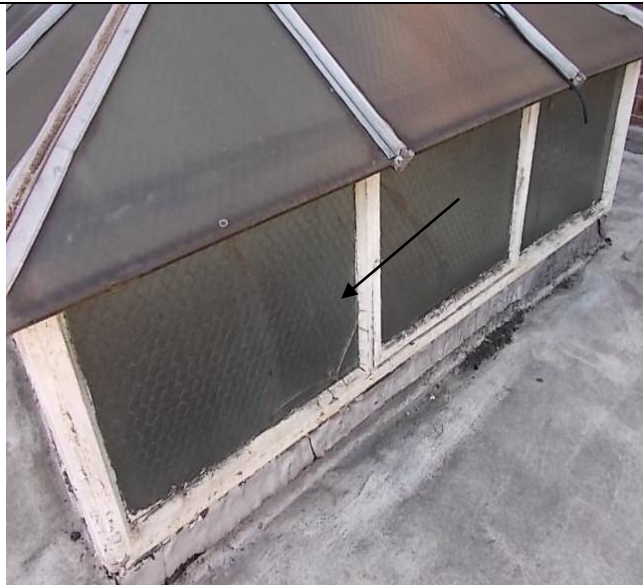
<b>Sample Reference:</b>	Inspection Point 25 Sample 22	<b>Asbestos Type:</b>	<b>No Asbestos Detected In Sample (NADIS)</b>
<b>Sample Location:</b>	External Flat Roof 1	<b>Product type:</b>	N/A
<b>Sample Description:</b>	Putty to frames of glass sky-light	<b>Accessibility</b>	N/A
		<b>Extent</b>	N/A
<b>Extent of Damage</b>	N/A	<b>Material Risk Assessment Total</b>	0
<b>Surface Treatment</b>	N/A	<b>Potential for Fibre Release</b>	N/A
<b>Recommended Action:</b>	<b>No asbestos was detected in sample. No further action required.</b>

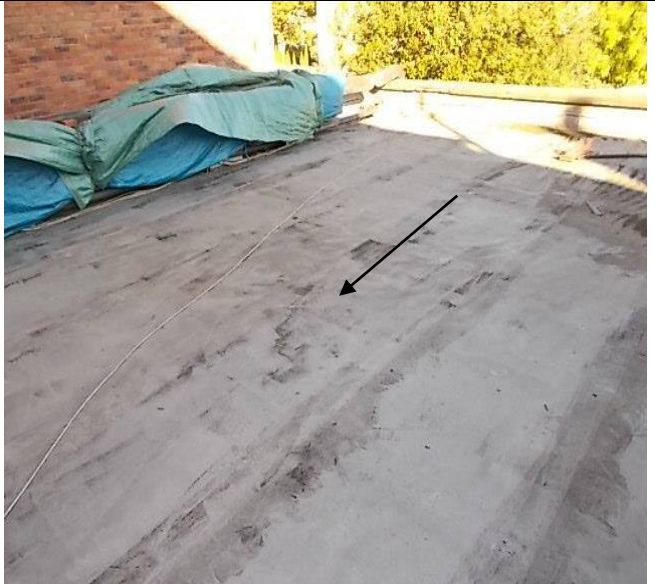
<b>Sample Reference:</b>	Inspection Point 26 Sample 23	<b>Asbestos Type:</b>	<b>No Asbestos Detected In Sample (NADIS)</b>
<b>Sample Location:</b>	External Flat Roof 2	<b>Product type:</b>	N/A
<b>Sample Description:</b>	Bitumen roof felt	<b>Accessibility</b>	N/A
		<b>Extent</b>	N/A
<b>Extent of Damage</b>	N/A	<b>Material Risk Assessment Total</b>	0
<b>Surface Treatment</b>	N/A	<b>Potential for Fibre Release</b>	N/A
<b>Recommended Action:</b>	<b>No asbestos was detected in sample. No further action required.</b>
