Asbestos Surveying Services

**Refurbishment/Demolition Survey
Of
The Queensbury Public House
110 Walm Lane
Willesden Green
London
NW2**

Date: 7th October 2015

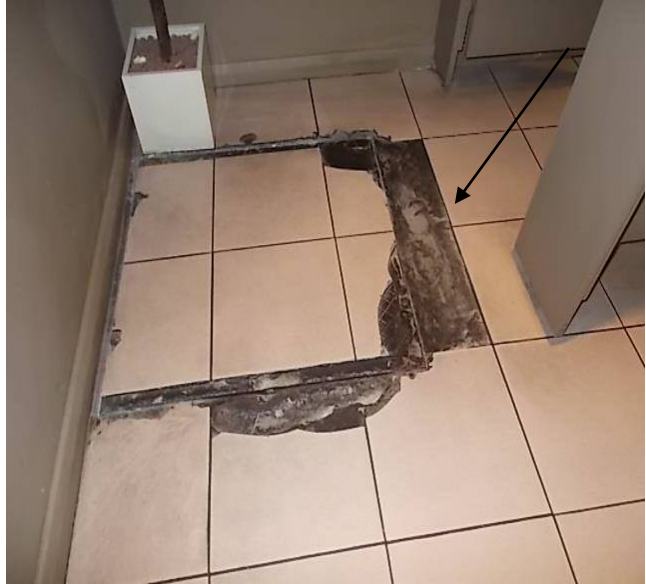
Sample Reference:	Inspection Point 01 Sample 1	Asbestos Type:	No Asbestos Detected In Sample (NADIS)
Sample Location:	Room 8 – Female W/C Ground Floor	Product type:	N/A
Sample Description:	Bitumen adhesive under ceramic floortiles	Accessibility	N/A
		Extent	N/A
Extent of Damage	N/A	Material Risk Assessment Total	0
Surface Treatment	N/A	Potential for Fibre Release	N/A
Recommended Action:	<p>No asbestos was detected in sample. No further action required.</p>

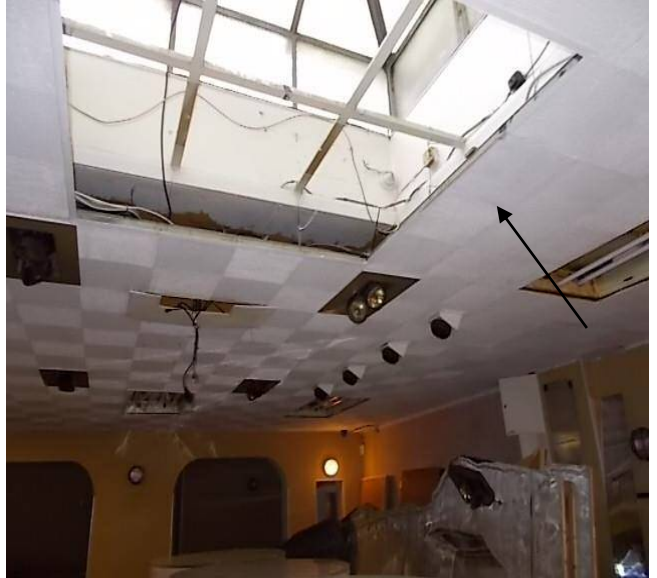
Sample Reference:	Inspection Point 03 Sample 3	Asbestos Type:	No Asbestos Detected In Sample (NADIS)
Sample Location:	Room 13 – Dance Floor Ground Floor	Product type:	N/A
Sample Description:	Ceiling tiles in suspended ceiling	Accessibility	N/A
		Extent	N/A
Extent of Damage	N/A	Material Risk Assessment Total	0
Surface Treatment	N/A	Potential for Fibre Release	N/A
Recommended Action:	<p>No asbestos was detected in sample. No further action required.</p>

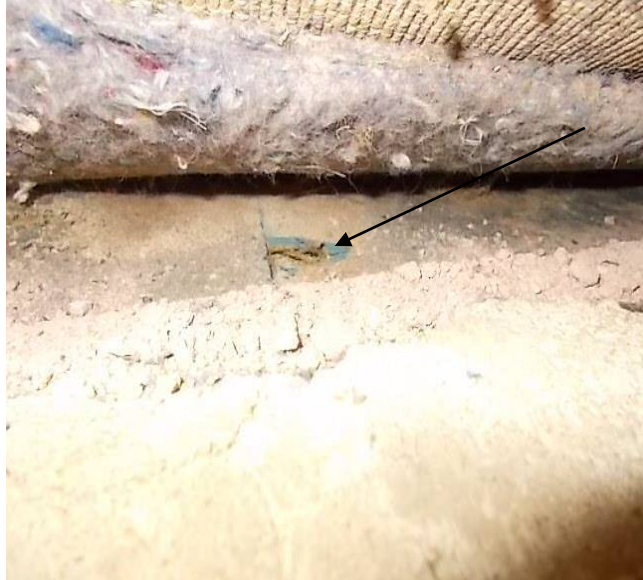
Sample Reference:	Inspection Point 05 Sample 5	Asbestos Type:	No Asbestos Detected In Sample (NADIS)
Sample Location:	Room 13 – Dance Floor Ground Floor	Product type:	N/A
Sample Description:	Vinyl flooring under carpet	Accessibility	N/A
		Extent	N/A
Extent of Damage	N/A	Material Risk Assessment Total	0
Surface Treatment	N/A	Potential for Fibre Release	N/A
Recommended Action:	<p>No asbestos was detected in sample. No further action required.</p>

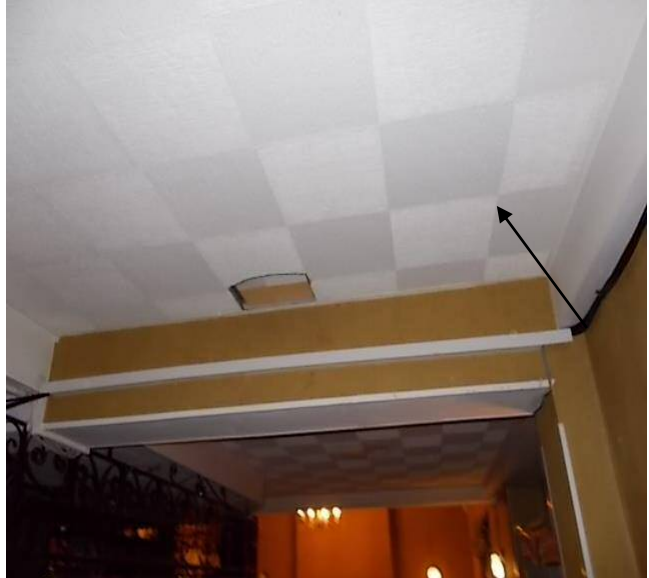
Sample Reference:	Inspection Point 06 As per Sample 3	Asbestos Type:	No Asbestos Detected In Sample (NADIS)
Sample Location:	Room 16 – Bar Area Ground Floor	Product type:	N/A
Sample Description:	Ceiling tiles in suspended ceiling	Accessibility	N/A
		Extent	N/A
Extent of Damage	N/A	Material Risk Assessment Total	0
Surface Treatment	N/A	Potential for Fibre Release	N/A
Recommended Action:	<p>No asbestos was detected in sample. No further action required.</p>

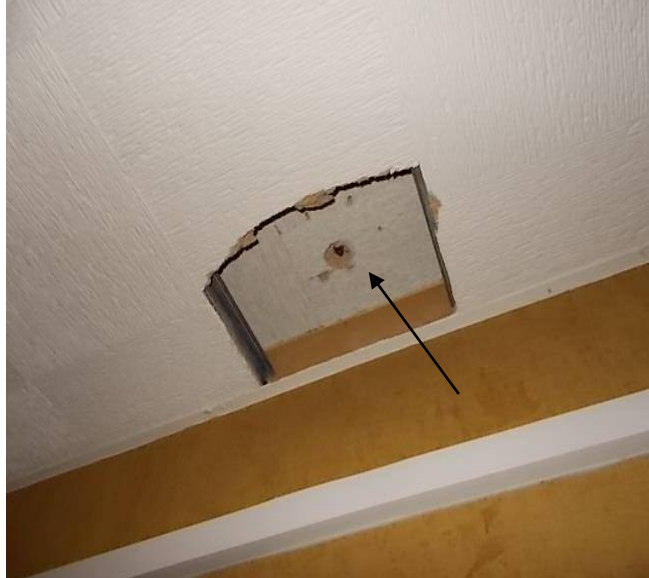
Sample Reference:	Inspection Point 07 Sample 6	Asbestos Type:	No Asbestos Detected In Sample (NADIS)
Sample Location:	Room 16 – Bar Area Ground Floor	Product type:	N/A
Sample Description:	Ceiling tiles above existing ceiling tiles in suspended ceiling	Accessibility	N/A
		Extent	N/A
Extent of Damage	N/A	Material Risk Assessment Total	0
Surface Treatment	N/A	Potential for Fibre Release	N/A
Recommended Action:	<p>No asbestos was detected in sample. No further action required.</p>

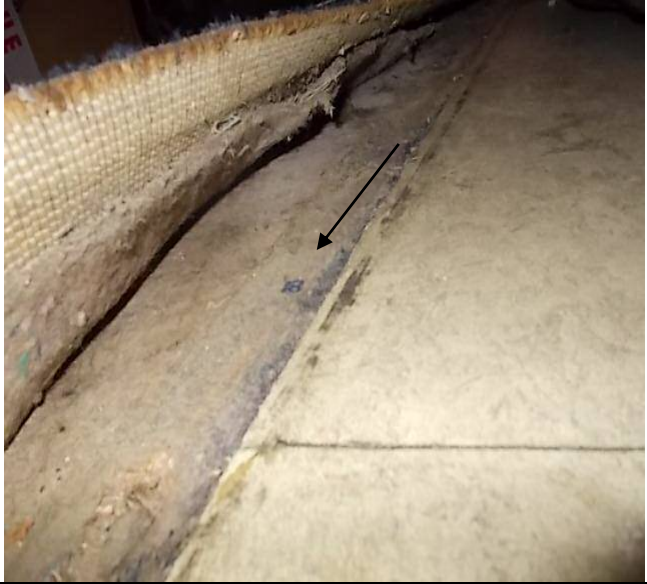
Sample Reference:	Inspection Point 08 Sample 7	Asbestos Type:	No Asbestos Detected In Sample (NADIS)
Sample Location:	Room 16 – Bar Area Ground Floor	Product type:	N/A
Sample Description:	Linoleum flooring under carpet	Accessibility	N/A
		Extent	N/A
Extent of Damage	N/A	Material Risk Assessment Total	0
Surface Treatment	N/A	Potential for Fibre Release	N/A
Recommended Action:	<p>No asbestos was detected in sample. No further action required.</p>

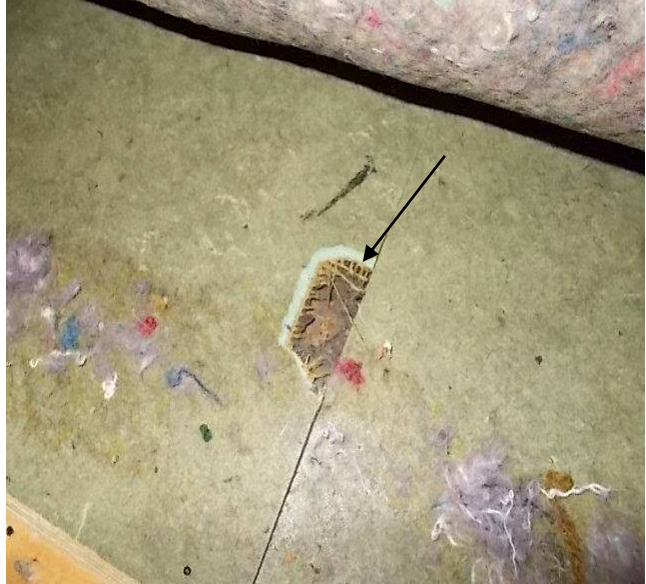
Sample Reference:	Inspection Point 10 Sample 9	Asbestos Type:	No Asbestos Detected In Sample (NADIS)
Sample Location:	Room 17 – Bar Area Ground Floor	Product type:	N/A
Sample Description:	Linoleum flooring and bitumen adhesive under carpet	Accessibility	N/A
		Extent	N/A
Extent of Damage	N/A	Material Risk Assessment Total	0
Surface Treatment	N/A	Potential for Fibre Release	N/A
Recommended Action:	<p>No asbestos was detected in sample. No further action required.</p>

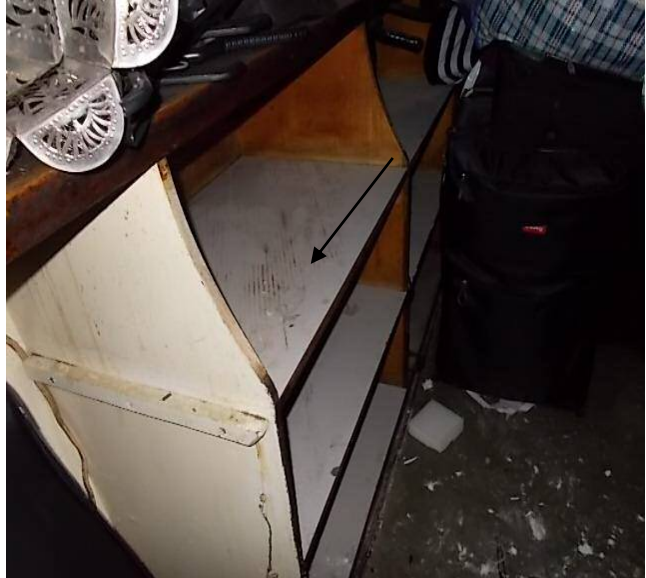
Sample Reference:	Inspection Point 12 Sample 11	Asbestos Type:	No Asbestos Detected In Sample (NADIS)
Sample Location:	Room 18 – Bar Ground Floor	Product type:	N/A
Sample Description:	Vermiculite coating to shelving under bar	Accessibility	N/A
		Extent	N/A
Extent of Damage	N/A	Material Risk Assessment Total	0
Surface Treatment	N/A	Potential for Fibre Release	N/A
Recommended Action:	<p>No asbestos was detected in sample. No further action required.</p>

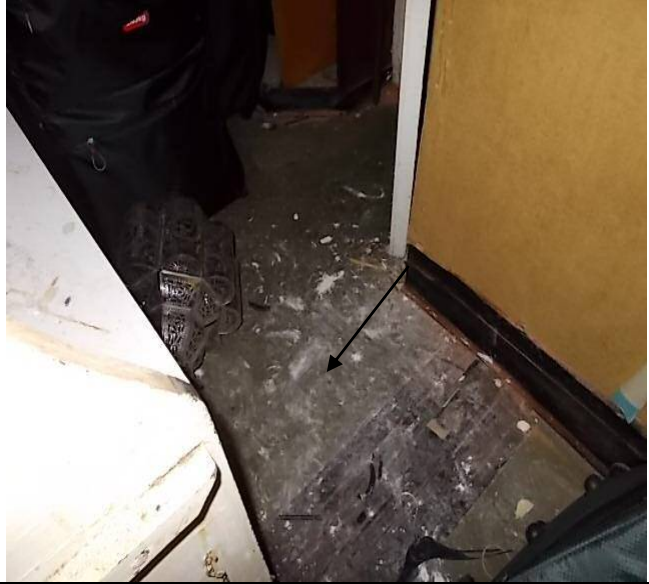
Sample Reference:	<p>Inspection Point 13 As per Sample 9</p>	Asbestos Type:	No Asbestos Detected In Sample (NADIS)
Sample Location:	<p>Room 18 – Bar Ground Floor</p>	Product type:	N/A
Sample Description:	<p>Linoleum flooring and bitumen adhesive</p>	Accessibility	N/A
		Extent	N/A
Extent of Damage	N/A	Material Risk Assessment Total	0
Surface Treatment	N/A	Potential for Fibre Release	N/A
Recommended Action:	<p>No asbestos was detected in sample. No further action required.</p>

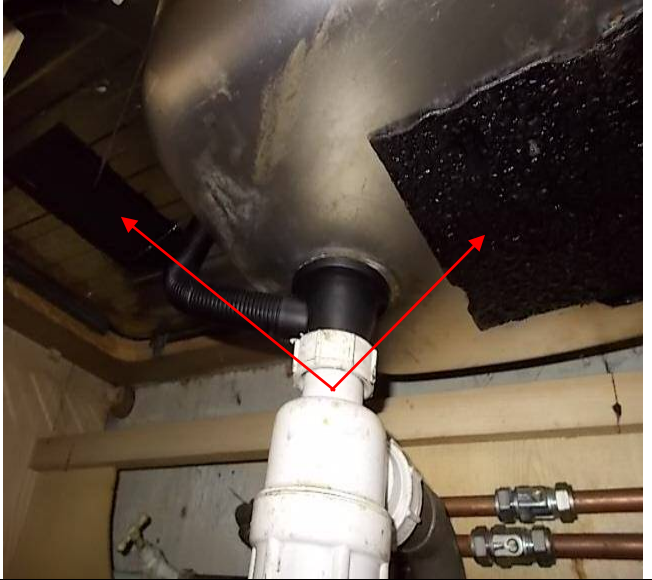
Sample Reference:	<p>Inspection Point 15 Sample 13</p>	Asbestos Type:	Chrysotile
Sample Location:	<p>Room 24 - Kitchen Ground Floor</p>	Product type:	Bitumen
Sample Description:	<p>Bitumen acoustic pads under sink unit</p>	Accessibility	Easily Accessed
		Extent	< 1 m ²
Extent of Damage	Good Condition	Material Risk Assessment Total	2
Surface Treatment	Sealed	Potential for Fibre Release	Very Low
Recommended Action:	<p style="text-align: center;">Label and manage or remove using a competent contractor in accordance with the Control of Asbestos Regulations 2012.</p>

- 4) Inspection Points 4, 14 and 15 were identified as containing Chrysotile. We recommend these incidences be labelled and managed or removed using a Competent Contractor under controlled conditions in accordance with the Control of Asbestos Regulations 2012.

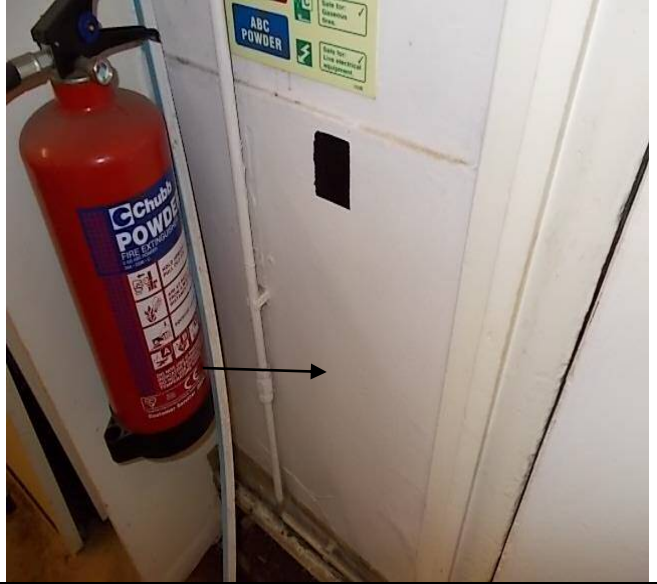
Sample Reference:	Inspection Point 16 Sample 14	Asbestos Type:	No Asbestos Detected In Sample (NADIS)
Sample Location:	Room 24 - Kitchen Ground Floor	Product type:	N/A
Sample Description:	Coating to panel on wall	Accessibility	N/A
		Extent	N/A
Extent of Damage	N/A	Material Risk Assessment Total	0
Surface Treatment	N/A	Potential for Fibre Release	N/A
Recommended Action:	<p>No asbestos was detected in sample. No further action required.</p>

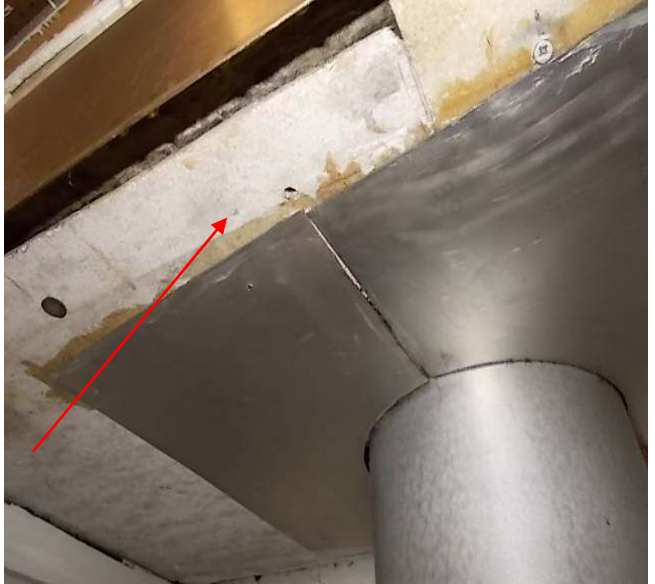
Sample Reference:	Inspection Point 17 Sample 15	Asbestos Type:	Amosite/Chrysotile
Sample Location:	Room 24 - Kitchen Ground Floor	Product type:	Asbestos Insulating Board
Sample Description:	Panel above boiler covering chimney	Accessibility	Easily Accessed
		Extent	1 m ²
Extent of Damage	Medium Damage	Material Risk Assessment Total	8
Surface Treatment	Not Sealed	Potential for Fibre Release	Medium
Recommended Action:	<p>Encapsulate and environmentally clean localised area, then label and manage or remove using a licensed contractor in accordance with the Control of Asbestos Regulations 2012.</p>

- 2) Inspection Point 17 was identified as containing Amosite and Chrysotile. We recommend this incidence be encapsulated and the area environmentally cleaned or removed by a Licensed contractor in accordance with the Control of Asbestos Regulations 2012.

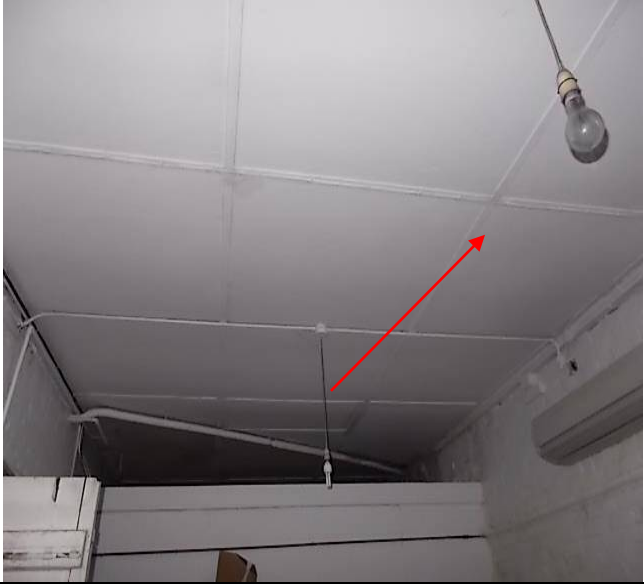
Sample Reference:	Inspection Point 18 Sample 16	Asbestos Type:	Chrysotile
Sample Location:	Room 26 - Garage Ground Floor	Product type:	Cement
Sample Description:	Cement board to ceiling	Accessibility	Easily Accessed
		Extent	38 m ²
Extent of Damage	Good Condition	Material Risk Assessment Total	3
Surface Treatment	Sealed	Potential for Fibre Release	Very Low
Recommended Action:	Label and manage or remove using a competent contractor in accordance with the Control of Asbestos Regulations 2012.

- 3) Inspection Points 18, 19 and 20 were identified as containing Chrysotile. We recommend these incidences be labelled and managed or removed by a competent contractor in accordance with the Control of Asbestos Regulations 2012.
