PHASE 1 ENVIRONMENTAL REPORT of a site at 219-223 COLDHARBOUR LANE, BRIXTON, LAMBETH, LONDON, SW9 8RU for COLDHARBOUR LANE LTD

Project No 0973 Report ref: 0973-P1E-1 Issued: July 2016

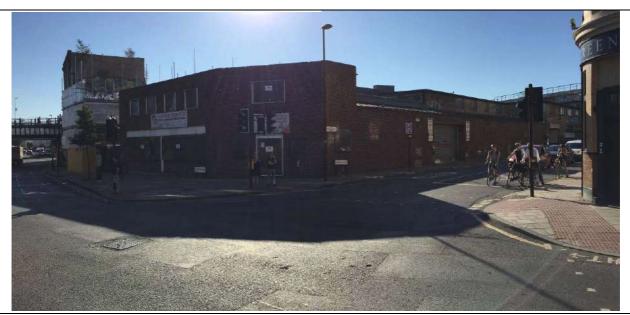
View Looking East towards Site

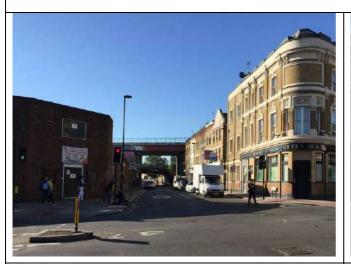
View Looking southeast from junction along Hinton Rd.

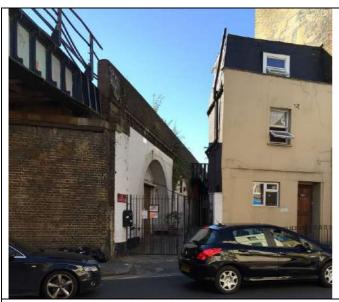
View Looking South from Coldharbour Lane of railway east of site

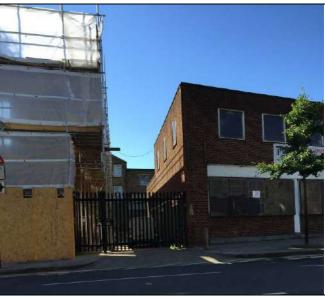
View Looking South of Access Way onto Site

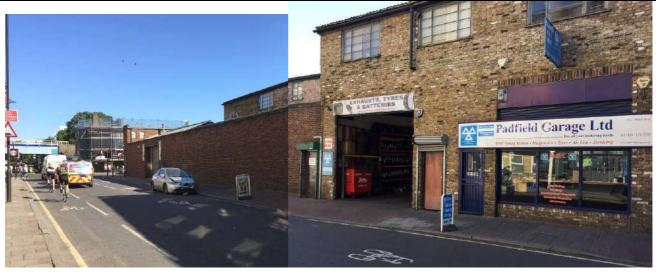
View of site Looking North from Hinton Rd

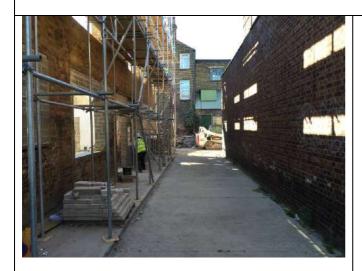
View of site Access Looking Southeast

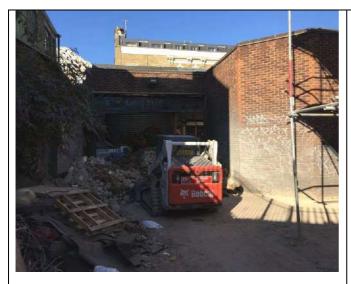
View Looking Southwest from Turning Head towards Building

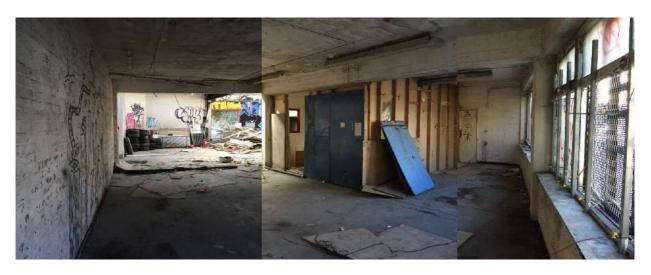
Internal view of Northern Building

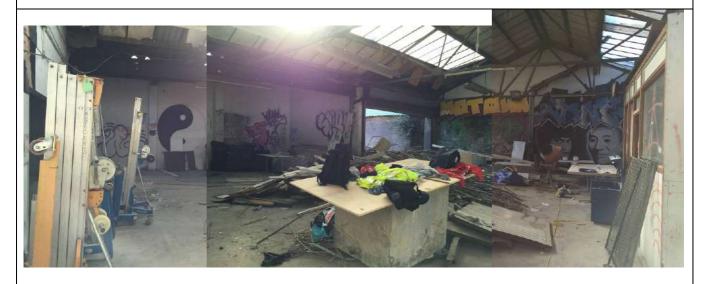
Internal view of Northern Building

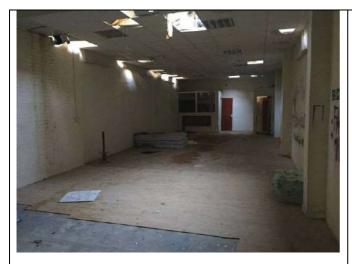
Internal view of Southern Building

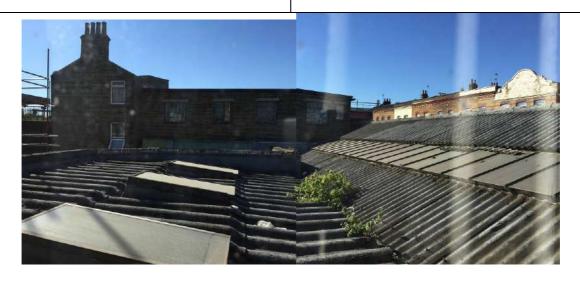
Roofscape Looking Southeast from first floor
