**GEO-ENVIRONMENTAL & GEOTECHNICAL ASSESSMENT
(GROUND INVESTIGATION)
REPORT**

**2 GASWORKS COTTAGE
STATION ROAD
BOREHAMWOOD
WD6 1DF**

Report Title: Geo-environmental & Geotechnical Assessment Report for 2 Gasworks Cottage, Station Road, Borehamwood, WD6 1DF

Job No: P1312J1279

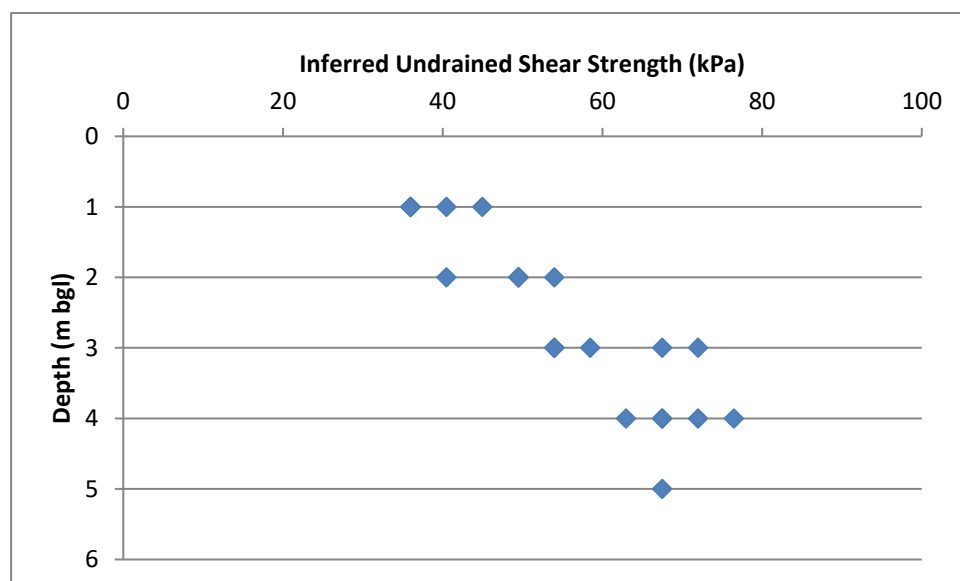
Figure 9.2: Undrained Shear Strength v Depth

9.4.3 The graph below shows the shear strength profile of the London Clay Formation encountered at the site, based on the SPT to shear strength correlation described above.

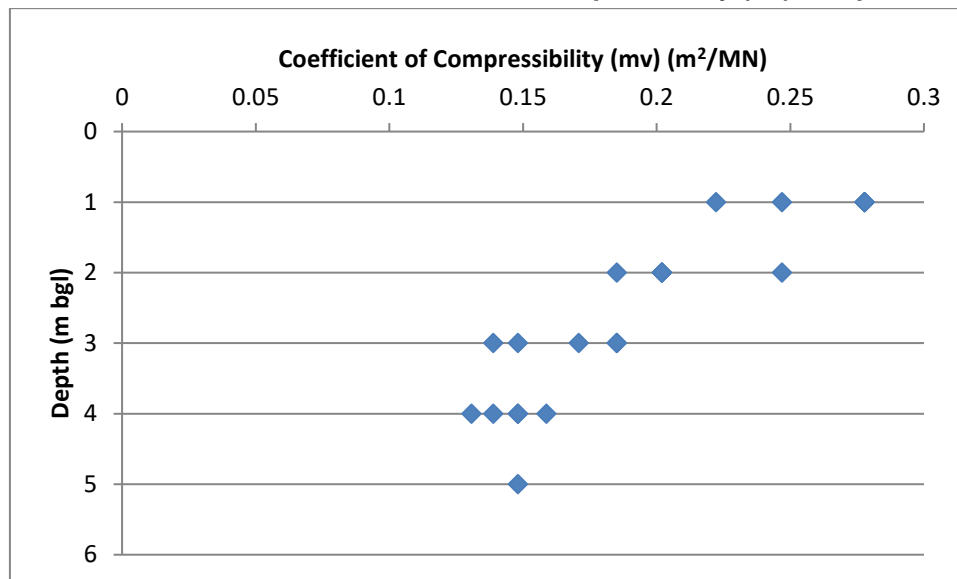
Table 9.3: of Coefficient of Volume Compressibility (m_v) v Depth

- 9.5.2 Using the plasticity indices obtained (See Table 9.1) and the graphs provided in Tomlinson (2001) a value of f_2 of 0.45 has been taken and used with the SPT 'N' values to infer coefficient of compressibility (m_v), these have been plotted against depth below in Table 9.2.

- 9.5.3 As would be expected the results reduce with depth as the clay increases in strength and the over burden increases, reducing the potential for compressibility.

- 9.5.4 The results from of the London Clay Formation are generally of “medium compressibility”, this is slightly higher than would be expected within London Clay Formation. This is considered to be due to the lack of overburden pressure and weathering of the clays that have allowed the overconsolidated clays to relax and so compress slightly.
