## Asbestos Surveying Services

Refurbishment/Demolition Survey  
Of  
Bishop House  
110 Walm Lane  
Willesden Green  
London  
NW2

**Date:** 30<sup>th</sup> September 2015

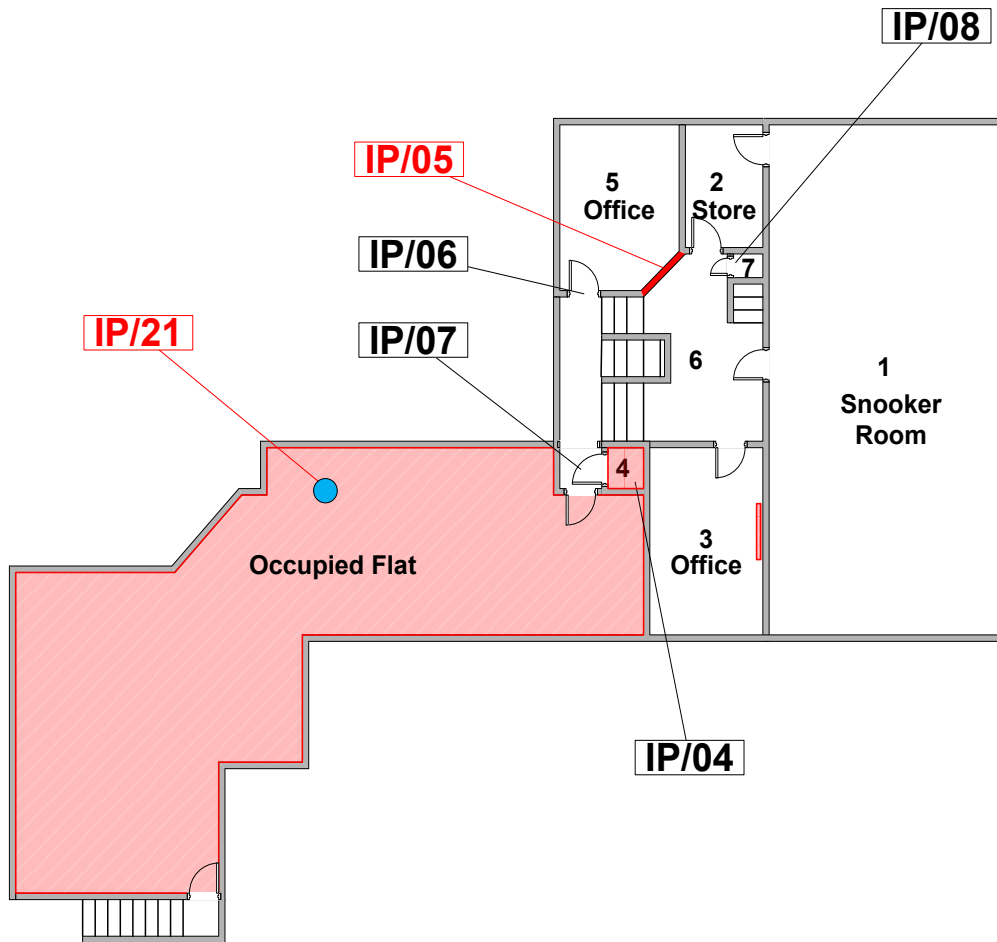
## 1st Floor

- IP/ Positive Inspection
- IP/ Negative Inspection
- No Access
- AIB Panel Covering Fireplace
- Cement Cowling To Top Of Brick Chimney

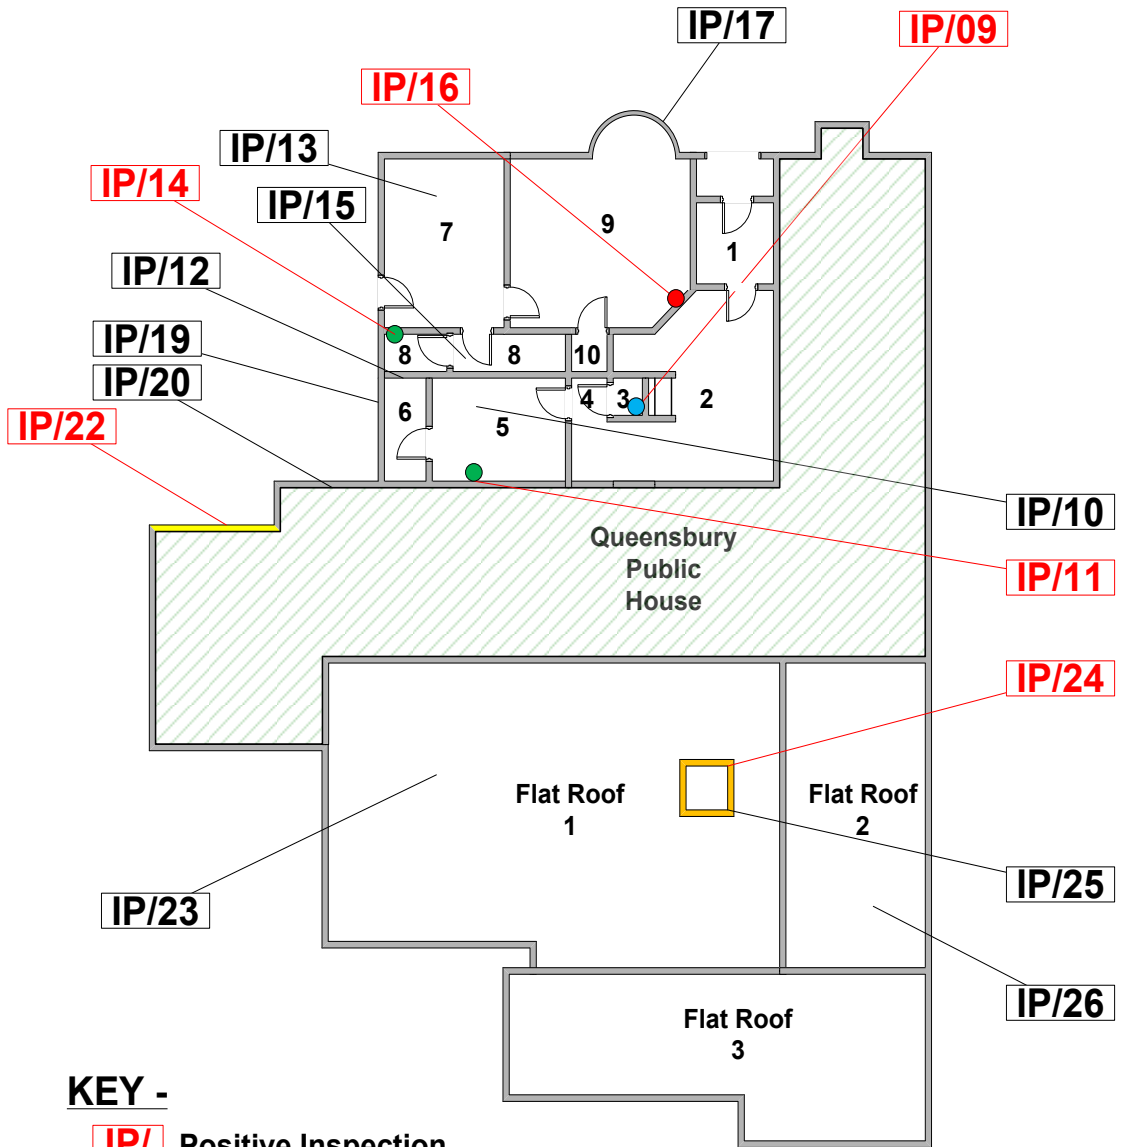
## Ground Floor

- IP/ Positive Inspection
- IP/ Negative Inspection
- Not in Scope Of Survey
- Redundant Cement Sheet
- Bakelite W/C Cistern
- AIB Debris Within Fireplace
- Bitumen Flashing Above Entrance To Garage
- Rope Beading To Glass Sky-Light
